On The Use of Remote Sensing and GIS Techniques in Post Earthquake Damage Identification and Assessment in Pakistan

(Presented at an Interdisciplinary International Workshop on Earthquake Risk Management,
held in Zurich, Switzerland, From August 28-29, 2006)

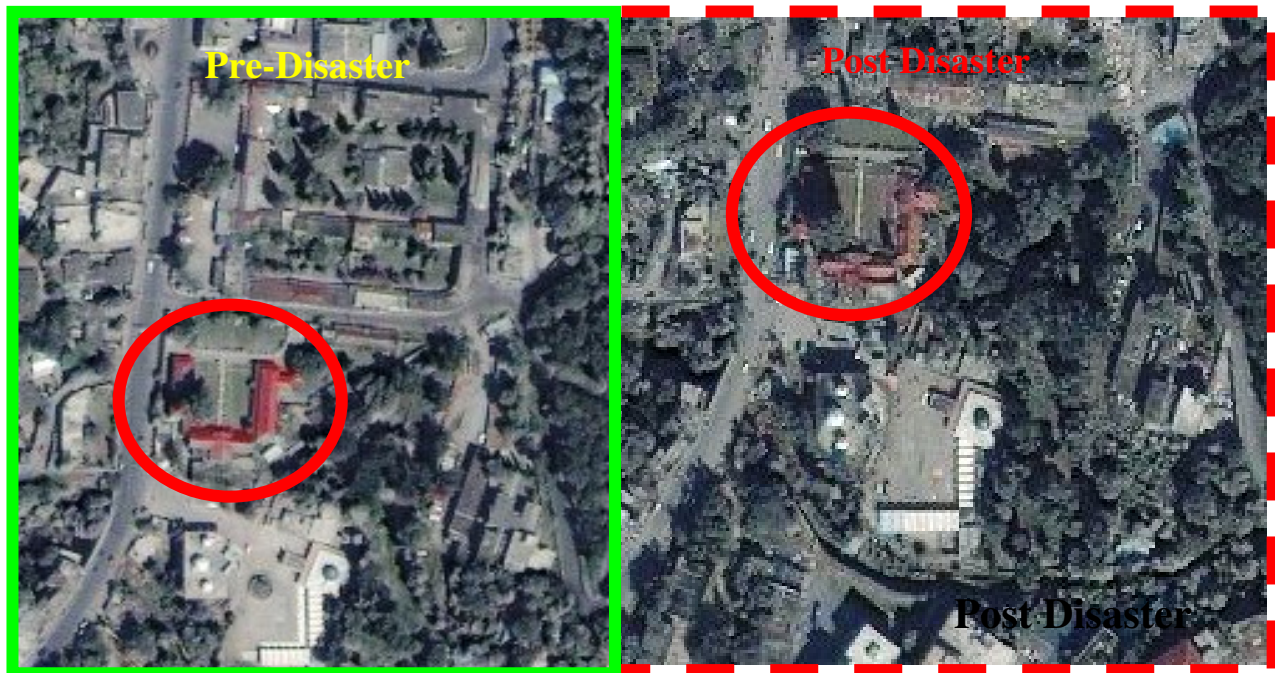
Figure-9. Pre and Post Earthquake Images of Muzaffarabad on IKONOS Imageries (Space Imaging (2005)

For visual interpretation we selected three types of satellite data from medium to fine resolution. On medium resolution Landsat 7 images for pre and post earthquake were chosen and downloaded from NASA's website. Even on this resolution the impact of earthquake is very prominent (Figure-7), in the pre earthquake image of November 2000 not a single landslide is noticeable, however, same area in the December 2005 is heavily occupied with the multiple landslides. On higher scale and zoom-in the same area near River Jehlum (Muzaffarbad) landslide is easily identifiable on IKONOS 1 meter resolution data (Figure-8). Not only landslide but also debris in the river is obvious and the color of the River Jehlum changed completely from blue to rock brown. On the same image devastation of the buildings is also evident. Another example of using remote sensing technology in building damage assessment is highlighted in Figure-9, where a building near AJK University is intact in pre earthquake image of IKONOS 1 meter and totally dismantled in post earthquake image.

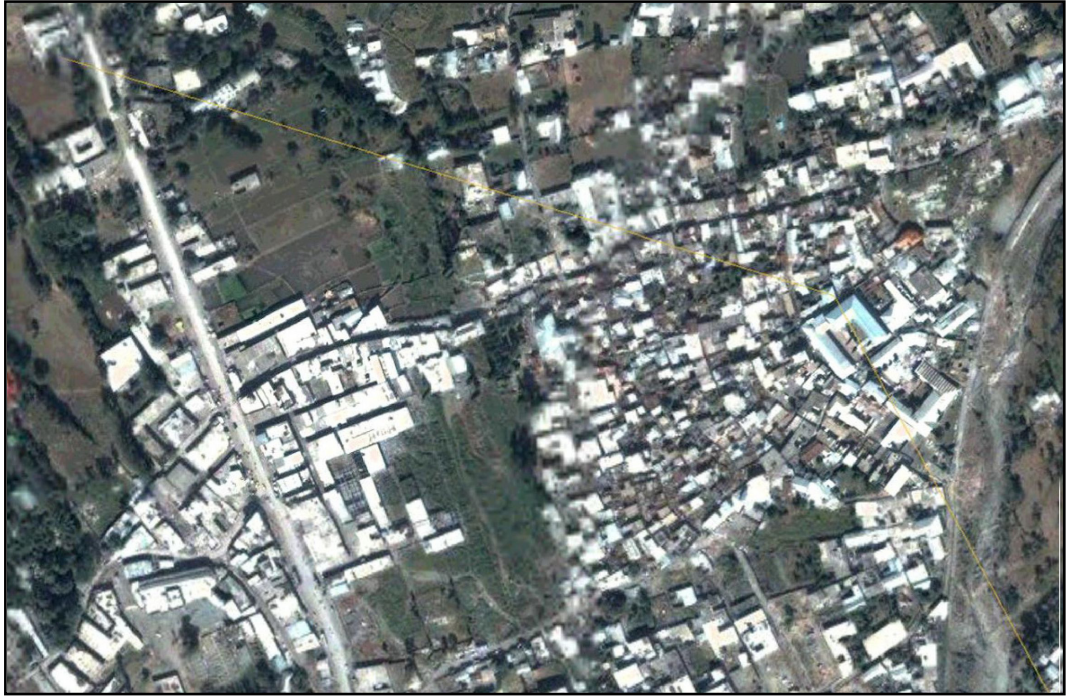
Figure-11: Area surveyed is shown as the subset of the image.

The same surveyed area is then downloaded through google-earth website, which has only post disaster images of QuickBird data on 61 cm spatial resolution. The image of this resolution is highly effective to see post disaster damages. The GPS coordinates converted into shape file and imported into ArcView software and these point then converted into polygons through field information (Figure-11 & 12). Each polygon is transformed into vulnerability class according to EMS. It is found that the totally collapsed buildings having zero shadows on the image, as the rooftop of the buildings is leveled with the floor, as result showing no or low shadows on this oblique image. With the help of supervised classification technique “zero shadow” areas were marked as training areas and a supervised classification algorithm has run, which finally gives the Figure-14. All zero shadows were isolated and enhanced in Figure-15 to represent a total picture of collapsed roofs. The results of the accuracy assessment of the shadow class is about 90% which could further enhanced if an original tiff image is acquired.
