# Interdisciplinary Workshop on Management of Earthquake Risks

## VULNERABILITY CURVES FOR MONUMENTAL BUILDINGS BASED ON SEISMIC DAMAGE OBSERVATION

Emanuela Curti, Sonia Giovinazzi, Sergio Lagomarsino and Stefano Podestà

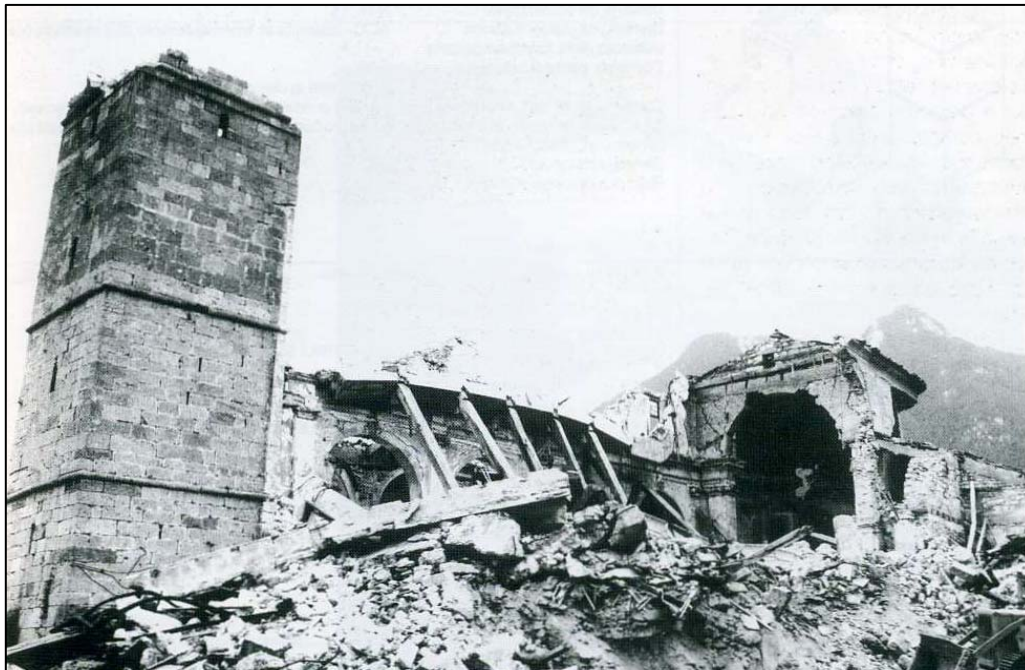
S. Stefano di Ceslans church – Cavazzo (UD)

After the main shock, replica tremors involved this area for four months and on September a shock of magnitude ML equal to 6.1 shocked the already damaged structures

During the damage and safety assessment, phenomena of damage accumulation were analyzed in detail, providing a series of indications useful to understand the seismic behavior of this kind of structures

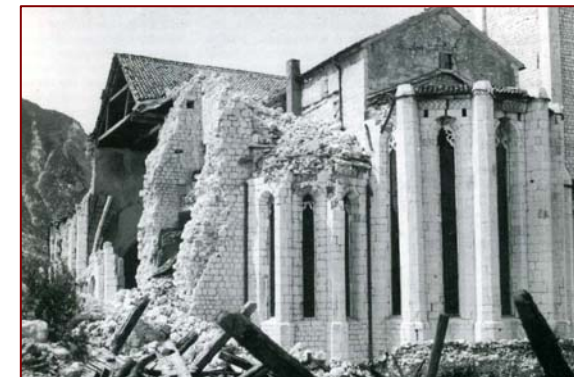
Venzone Cathedral after the first mainshock

**Venzone Cathedral:** re-built according to “*anastilos*” methodology: every ashlar has been catalogued and re-located in the original position.

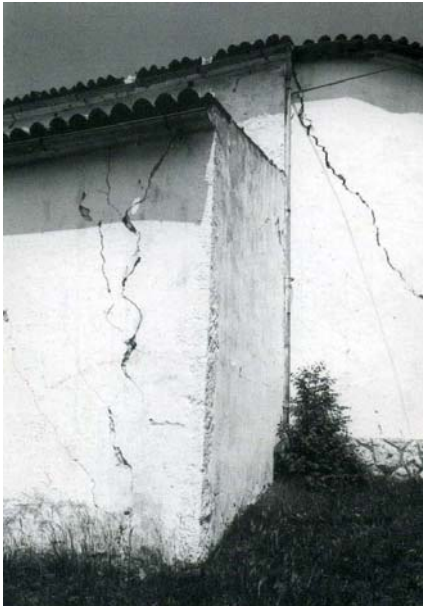
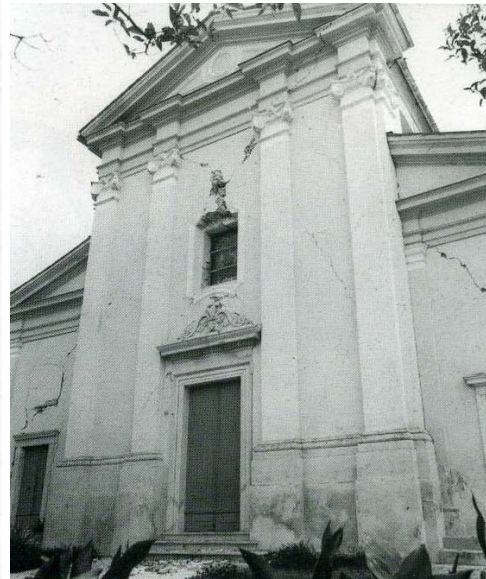
S. Rocco church - Forgaria (UD)

Pignano Church - Ragonga (UD)

Out-of-plane seismic action causes overturning damage mechanisms.

In-plane seismic action induces sliding or shear failures, characterized by oblique ( $45^\circ$ ) cracks

**Damage mechanism:** kinematism through which the different parts of the construction (macroelements) come to collapse. Generally (in case of good masonry quality) the damage mechanism can be associated to rotation or sliding between masonry portions, schematized, for easiness, as rigid bodies.

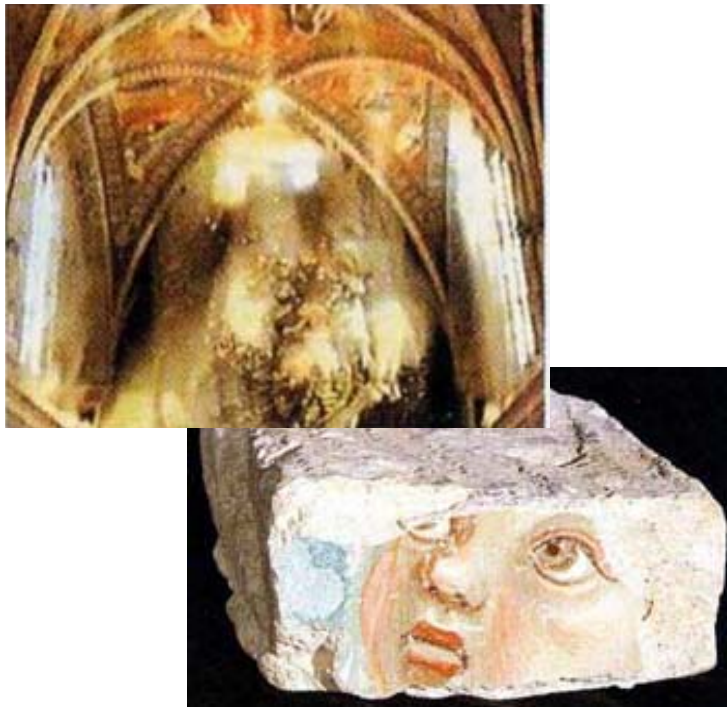
Collapse of S. Francesco d'Assisi vault – Assisi (PG)

The Umbria and The Marches seismic sequence is characterized by three main shocks (September 1997 – epicenter Colfiorito; October 1997 – epicenter Sellano; March 1998 – epicenter Gualdo Tadino). More than 1000 churches were damaged by the earthquake (magnitude 5.8). The vaults of S. Francesco d'Assisi Basilica partially collapsed causing the death of 4 people.

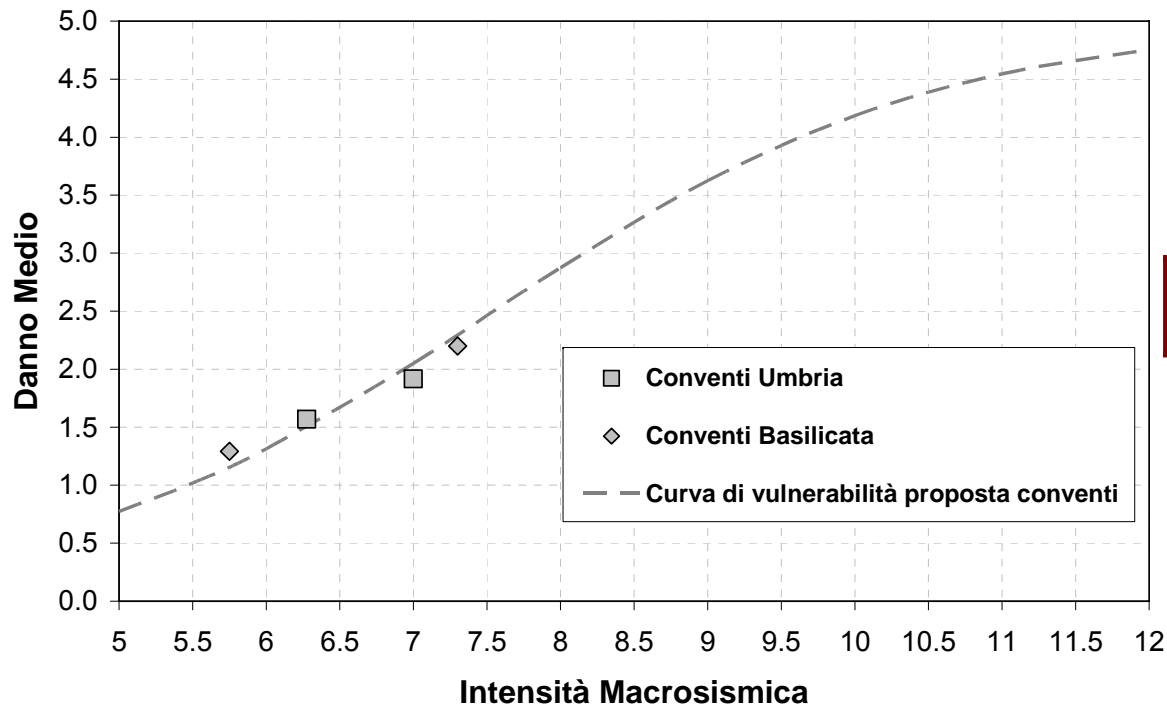
# CONVENTS

$Q = 3$	$V = 0.89$
---------	------------

The same vulnerability curve used for the churches is adopted for the convents

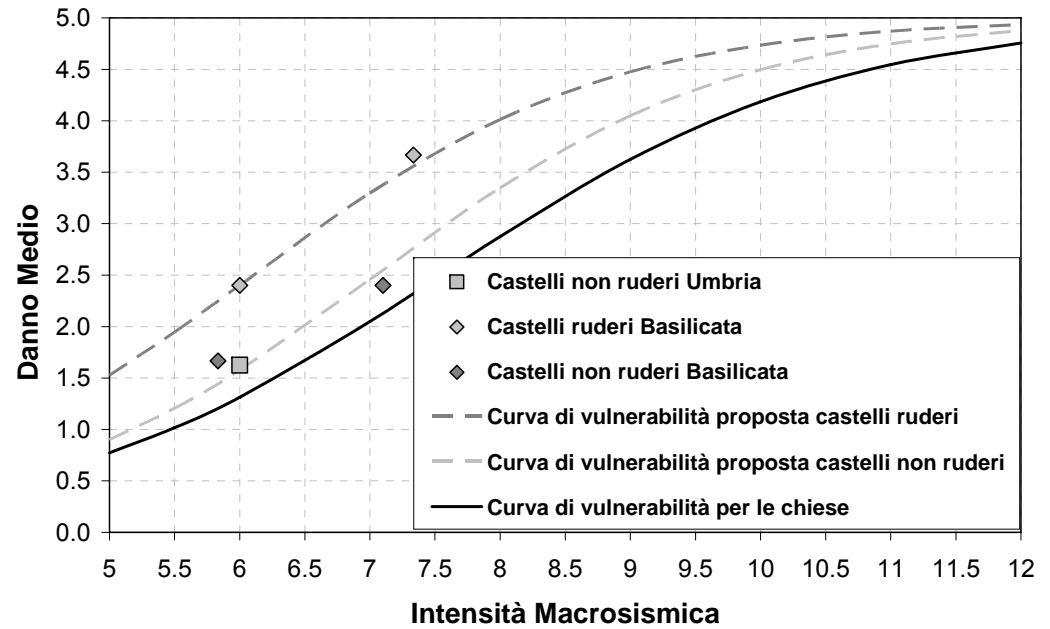
# CASTLES

$$Q = 2.7$$

$$\Delta V_1 = 0.2$$

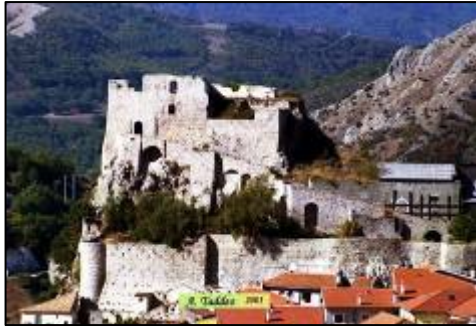
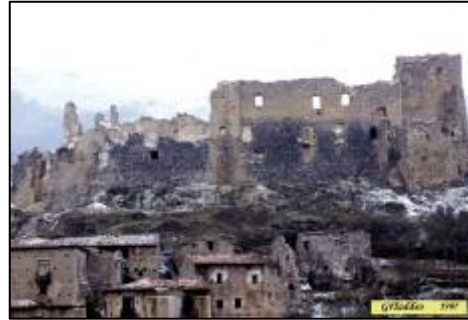
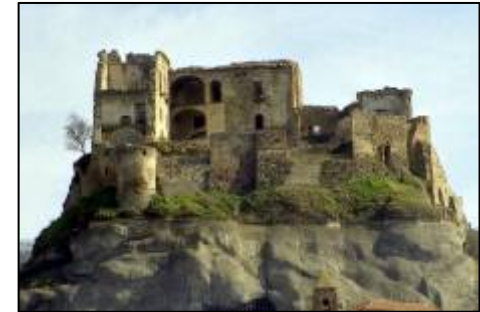
State of maintenance before the seismic event: **ruin**

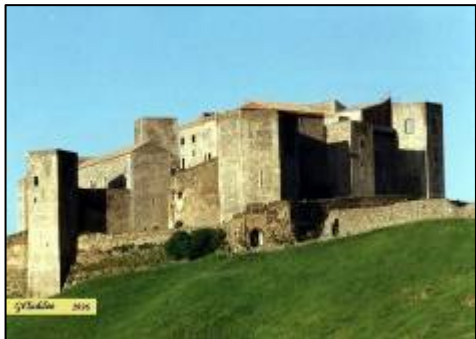
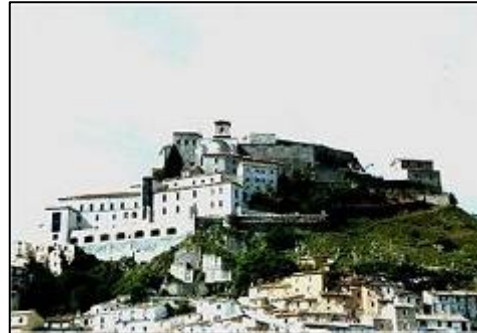
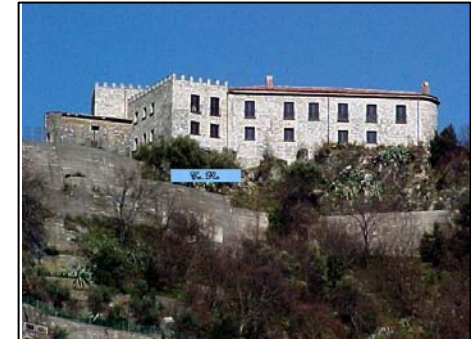
State of maintenance before the seismic event: **not-ruin**

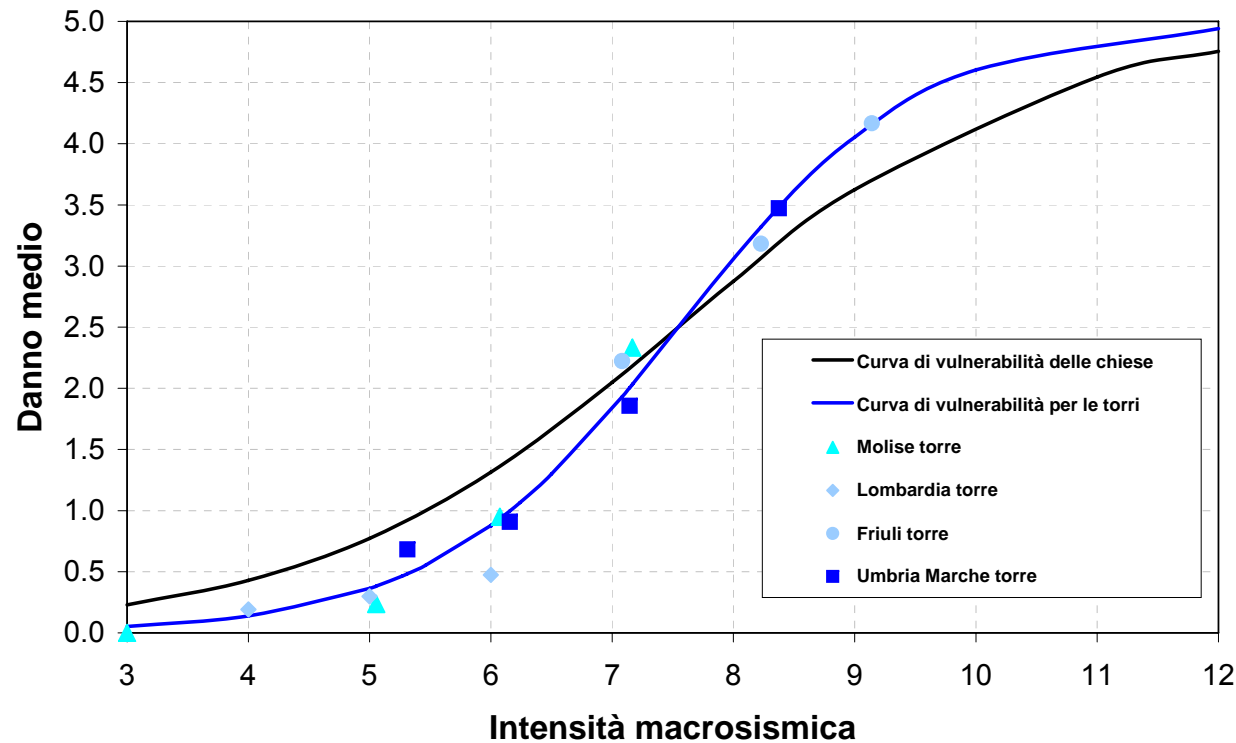
# BELL TOWER

$$Q = 2$$

$$V = 0.89$$

Limited vulnerability for low macroseismic intensity. Rapid increment of the damage when the seismic severity increases

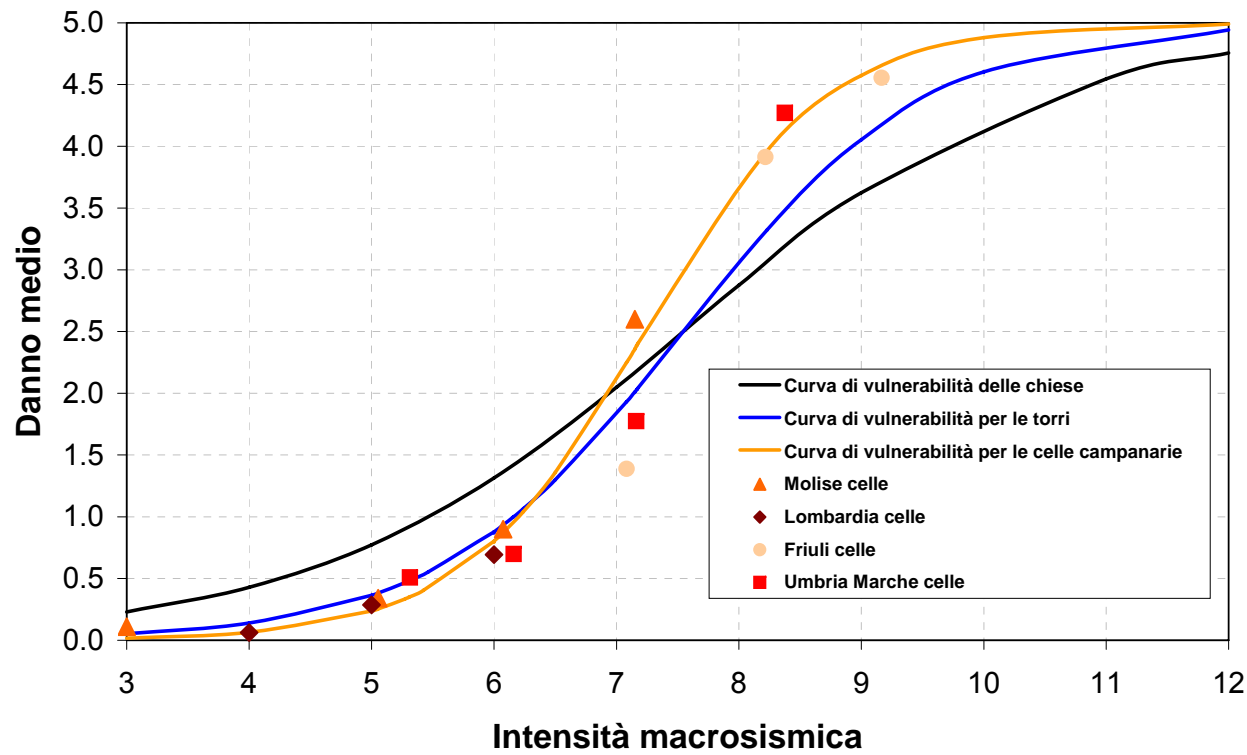
# CELL OF THE BELL TOWER

$$Q = 1.49$$

$$V = 0.94$$

- Lower displacement capacity for the pier of the cell
- The seismic demand, in term of displacement, is higher for the cell

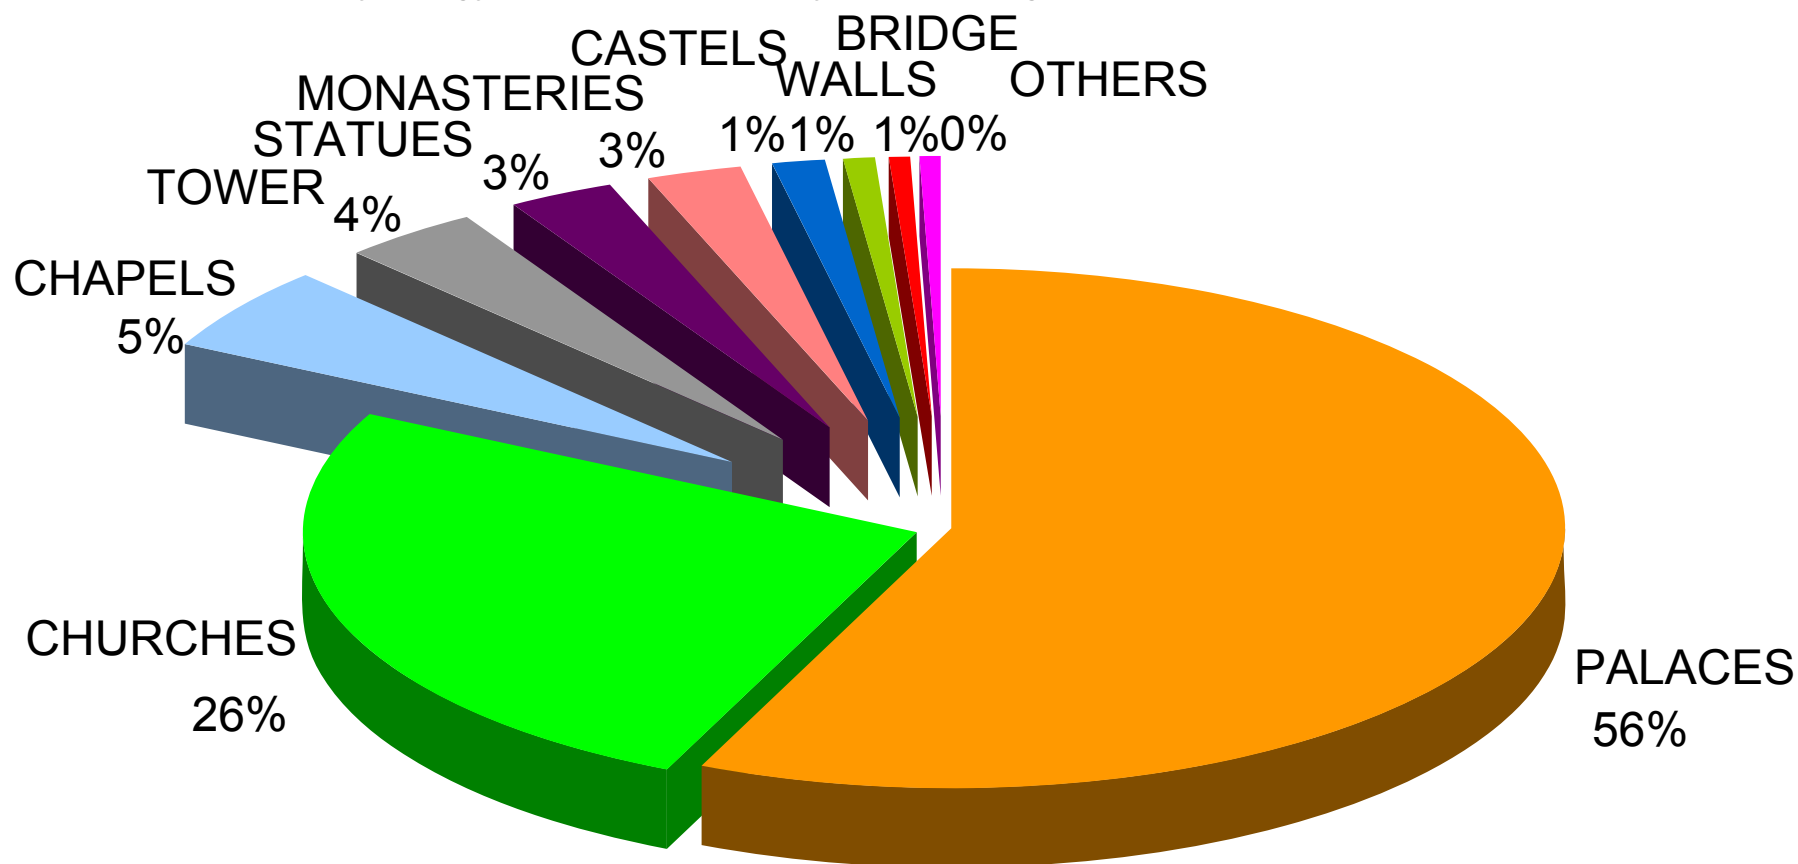
Level 1 vulnerability analysis of the cultural heritage for the parks of South of Italy (LSU Park Project)

Distribution of the typology for the 1400 analyzed buildings
